**Aircraft Accident Investigation Bureau**

Aircraft Accident Investigation Preliminary Report

B737-8 (MAX) Registered ET-AVJ

Report No. AI-01/19

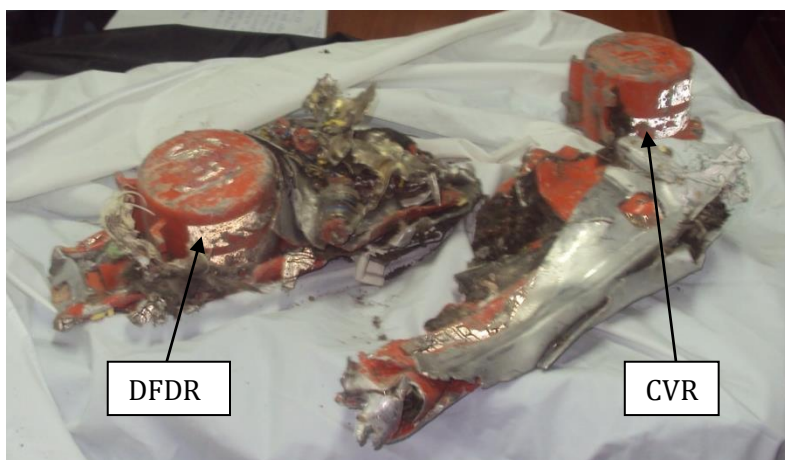
DFDR and CVR as discovered on the accident site.

On 11 March 2019, the CVR was recovered from the accident site by the AIB. The CVR CSMU was transported to the BEA recorder facility for data downloading. The CSMU was found separated from the chassis during wreckage recovery. The read-out was performed by BEA investigators under the authority of the Ethiopian Accident Investigation Bureau (AIB), with the participation the National Transportation Safety Board (NTSB) of United States of America, the Boeing Company, and the Federal Aviation Administration (FAA).

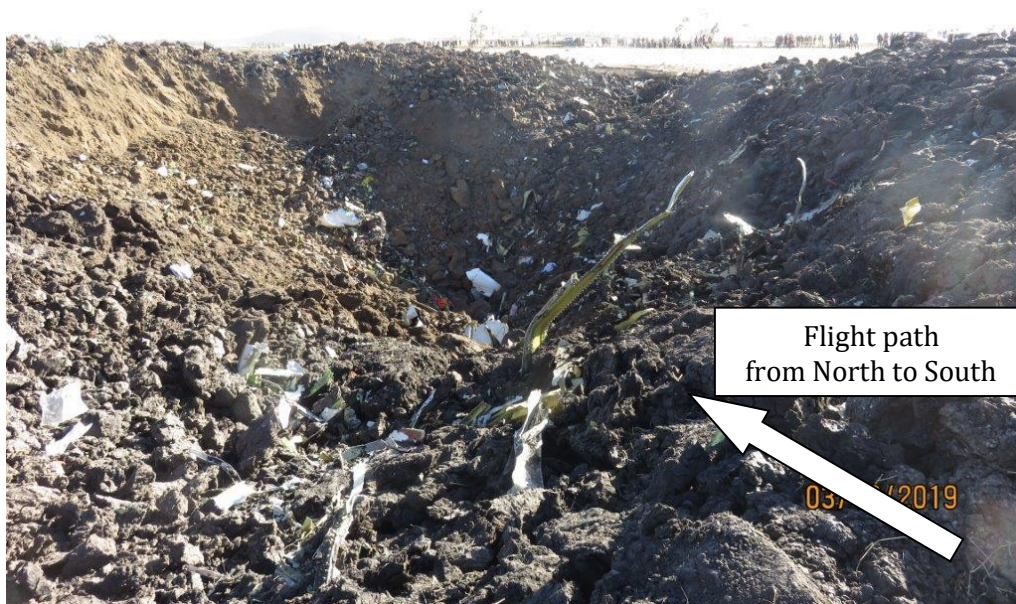
Both engines were found buried in the ground at a depth of approximately 10 meters. To access the buried wreckage (engines, aircraft structure and components), backhoes were used to remove the wreckage from the area around the impact point.

Close view of the crater before excavation
